NATIONAL ADVISORY COMMITTEE FOR AERONAUTICS

TECHNICAL NOTE 3990

EFFECT OF CRYSTAL ORIENTATION ON FATIGUE-CRACK
INITIATION IN POLYCRYSTALLINE
ALUMINUM ALLOYS

By J. G. Weinberg and J. A. Bennett

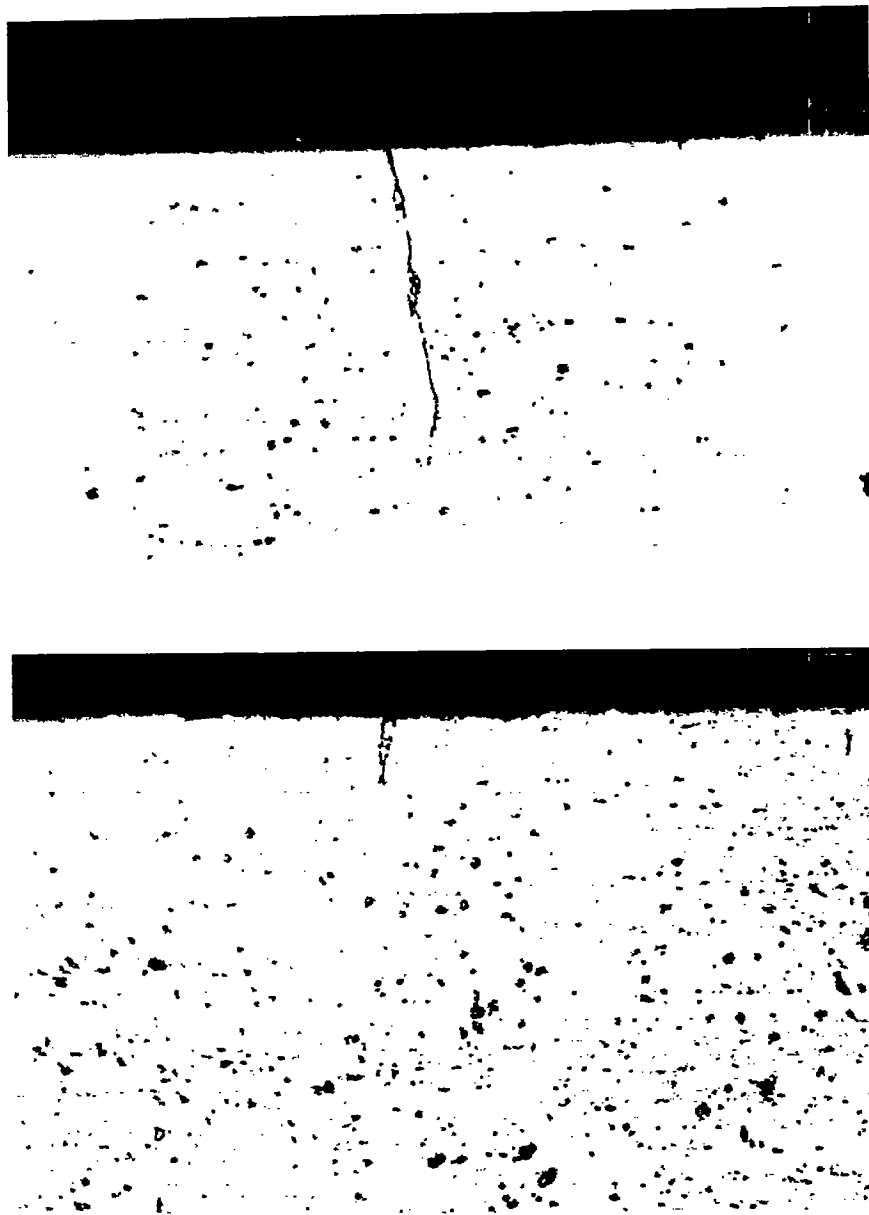
Figure 7.- Typical cracks on a longitudinal section of specimen shown in figure 5, lightly etched in Keller's etch. Magnification, X250.
